Food grade stainless steel Labyrinth trap/silencer

mbar Labyrinth traps reducing product downgrade

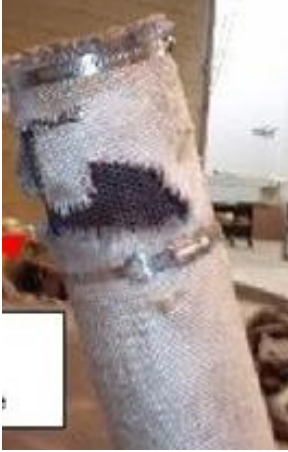
The photo on the left shows the inside of absorptive silencer – the fiberglass mesh has deteriorated/disintegrated in place – this wasn't discovered until removed and silencer cut open – result, contaminated product!

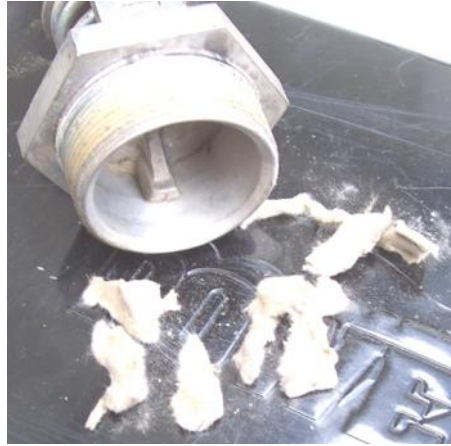
The photo on the right shows a pressure relief valve which has been removed from a blow line down air stream from an absorptive silencer. The material (fiberglass) in the photo has been caught in the pressure relief valve. How much went into the product? Our estimate – 5x more!

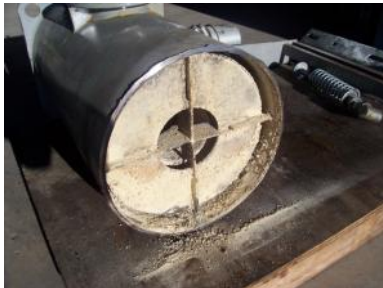
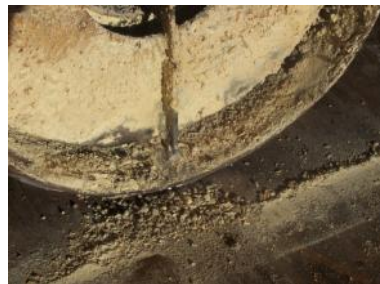
The next two photos show product buildup (creating a mould spore factory!) inside a reactive silencer. The silencer in the photo was cut apart using a disc grinder. It was not possible to clean it to a satisfactory standard so was discarded and replaced with a cleanable mbar trap. The air velocity in the pipeline from the process is designed to convey powder products. The silencer is in the same pipeline; ***therefore, if foreign bodies get into the air stream they will end up in the product.***

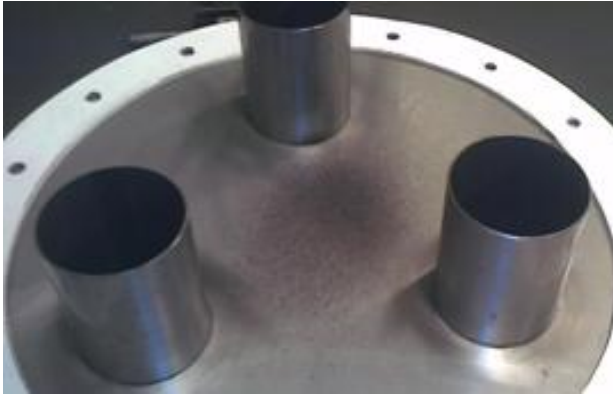
The photo on the left shows lubricant droplets caught inside an mbar labyrinth/trap silencer giving early warning of seal failure in the blower and stopping product contamination. If the silencer in this product line was an absorptive or reactive silencer a) the early warning sign would have been missed causing pump failure and b) product contamination would have occurred.

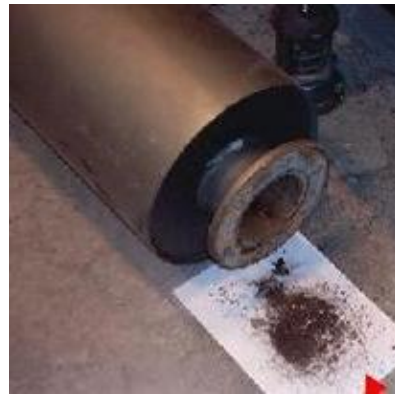
The photo on the right shows foreign matter discovered inside an absorptive silencer once it was removed during a root cause analysis following product contamination.
